TOXIC CITY **№** SICK SCHOOLS

Barbara Laker, Wendy Ruderman and Dylan Purcell Edited by Jim Neff; photos by Jessica Griffin

The Philadelphia Inquirer & Daily News

So you're thinking of investigating environmental hazards inside public schools?

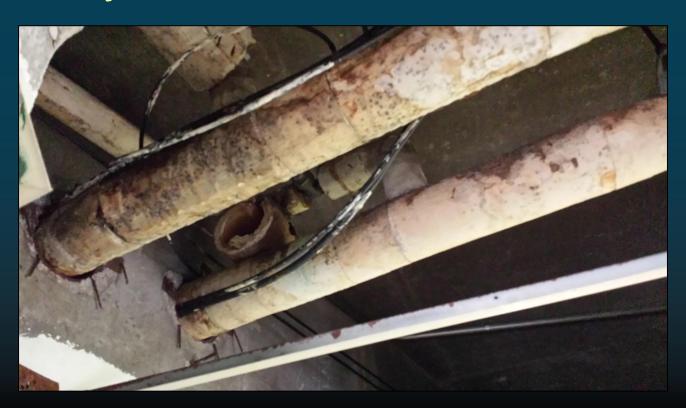
Photos can be vital. This is what a moldy pipe at JB Kelly looked like:

Here, JB Kelly elementary had moldy, damaged asbestos in a kindergarten room:

Kelly J.B. ES	6470	79	3/16/2016	Kindergarten (K- 3) Closet		An asbestos Design Data Collection (DDC) package was issued on 3/17/16.	Mold/Moisture	Environmental		Water stained fiberglass pipe insulation was observed. This section of pipe insulation is covered with a layer of asbestos containing textured ceiling overspray.	closed	No	4/13/2016	МО
Kelly J.B. ES	6470	80	3/16/2016	Kindergarten (K- 3) Closet		Replace the fiberglass pipe insulation on the dual temperature line.	Mold/Moisture	Steamfitting		Pipe insulation was missing from a section of piping.	closed	No	3/16/2016	NO
Kelly J.B. E8	6470	81	11/10/2016	Room 105	16 LF	A mold Design Data Collection (DDC) package was issued on 11/10/16.	Mold/Moisture	Environmental		Mold growth was observed on the fiberglass pipe insulation located above the suspended ceiling near the teacher's desk.	closed	No	12/29/2016	NO
Kelly J.B. E8	6470	82	11/10/2016	Room 105	1 EA	Evaluate and repair the leaking pipe above the suspended ceiling.	Mold/Moisture	Steamfitting		An active leak was observed on a 4" line located above the suspended ceiling near the teacher's desk. The teacher indicated it has been leaking for months and rusted the metal file	closed	No	1/18/2017	NO

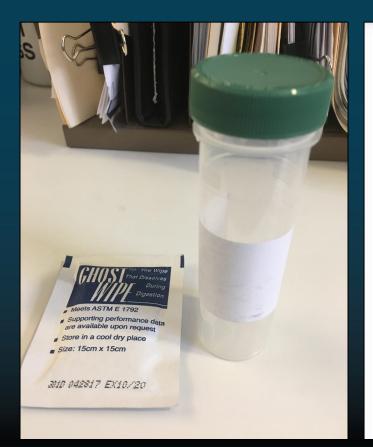
SAMPLING FOR ASBESTOS FIBERS WITH A DUST WIPE

We purchased lab equipment and made testing kits with written instructions for teachers and staff

Thank you for assisting our research project looking at the potential for asbestos fibers in settled dust. Follow these easy steps to complete this test:

- Find a place on the floor, a shelf, a desk top, a windowsill, a cubbyhole, or another area
 that appears to have dust or is located near and deteriorated asbestos and is accessible
 to small children and teachers. (You're looking for damaged or chipped floor tiles, pipe
 insulation, ceiling tile, plaster, spackle.) If you can, take a photo of the area prior to
 wining.

- Put on a pair of disposable gloves. Open the dust wipe sample packet and unfold the wipe.
- In a square area that is about 4 by 4 inches (or 10 by 10 centimeters), make as many 5like motions as needed to wipe the entire sample area, moving from side to side and top to bottom of the 4 by 4-inch square. Apply firm pressure on the wipe.

- Fold the wipe in half, keeping the dirty side in, and repeat the wiping procedure. (see below). Flip the wipe and repeat.
- Now fold the wipe into an even smaller square (roughly the size of the wipe packaging) and repeat again, concentrating on collecting dust from the edges and corners of the sample area.

- Stuff the wipe into the sample tube. Put the cap tightly on the container. On the label, write the school name, time and date, room number and specific area from which the sample was taken (such as Rm. 101, floor tile, under window ledge).

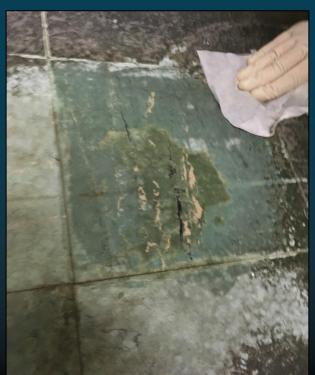
Damaged asbestos tiles in a school auditorium

We asked teachers and staff to take photos of where they tested. This helped verify their work
